ANCIENT STUPAS IN SRI LANKA – LARGEST BRICK STRUCTURES IN THE WORLD

Munidasa P Ranaweera, Department of Civil Engineering, University of Peradeniya, Sri Lanka.

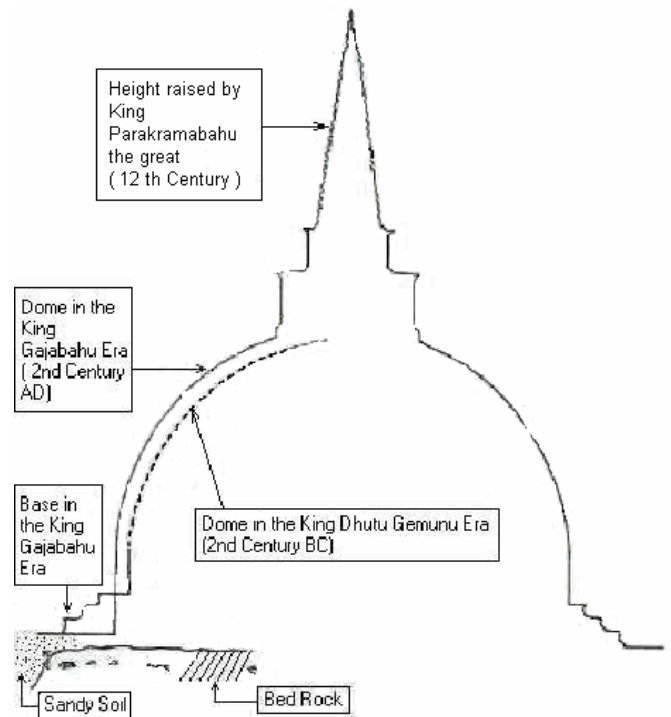
Figure 9. Development of Miriseveti Stupa

The last mega stupa built by the kings is Rankothvehera (Fig. 8), or the Golden Pinnacle Stupa, in Polonnaruwa, the medieval capital of Sri Lanka. King Parakramabahu who reigned there was responsible for the enlargement of many stupas built by his predecessors and his Kirivehera (Fig. 7) is important due to the fact that it still retains the original brickwork and plaster. Mirisaveti (Fig. 3) was enlarged several times by kings who came after Dutu Gemunu (Fig. 9), and its latest restoration was completed by the Sri Lankan government in 1995.

offer flowers etc. were built. In some stupas the basal rings were added after the dome was built (Fig. 9), and in some the they formed the plinth for the dome. Some of the large stupas were also provided with projections called *vahalkadas* (Fig. 10) or frontispieces [Paranavitana 1946]. These, numbering one to four are placed at cardinal points of the stupa, and some of them have developed into beautifully ornamented structures.

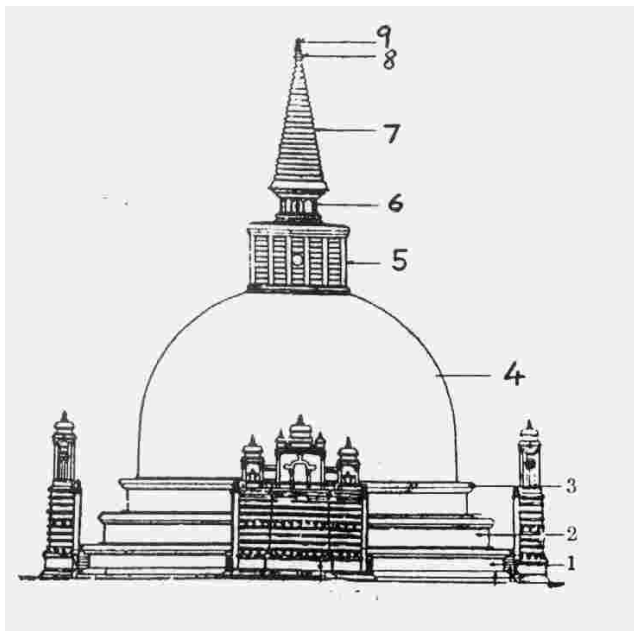
Figure 10. Main components of a Stupa (1,2,3-Basal rings, 4-Dome, 5-Square Chamber, 6-Cylinder/s, 7-Spire, 8-Mineret, 9-Crystal)

Main components of the Sri Lankan stupa are shown in Fig. 10. The stupa dome has one, two or three cylindrical terraces or basal rings at the bottom. At its top, the dome carries the square chamber, which is a solid structure having a square plan. Then comes one or more cylinders, the spire and the pinnacle. All these components, except the square chamber, are axisymmetric.

The square chamber at the top of the dome was hollow at ancient times, and even after it became solid, its faces show railings (Fig. 10). On top of the square chamber there are one or more cylinders, some known as the abode of gods, having figures of deities. The conical spire, on the top of the cylinder is a solid, giving the impression of a number of umbrellas put together, and at its top rests a crystal set on a gilt minaret (Fig. 10).

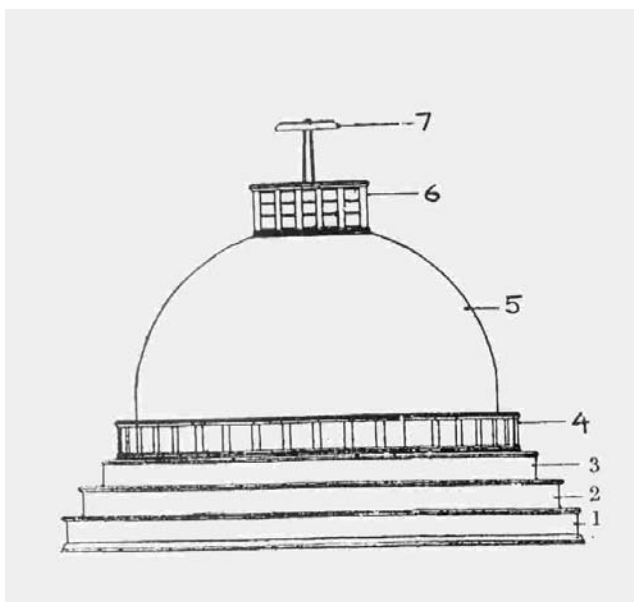
Figure 11. Indian Form of Stupa (1,2,3-Basal rings, 4-Railing, 5-Dome, 6-Square chamber(hollow), 7-Umbrella)

Originally the components above the dome were similar to the Indian form (Fig. 11), and consisted of a hollow square chamber, inside which there was a column carrying one or more umbrellas. The umbrellas protected the stupa from rain when the stupa was of very small size, but when the

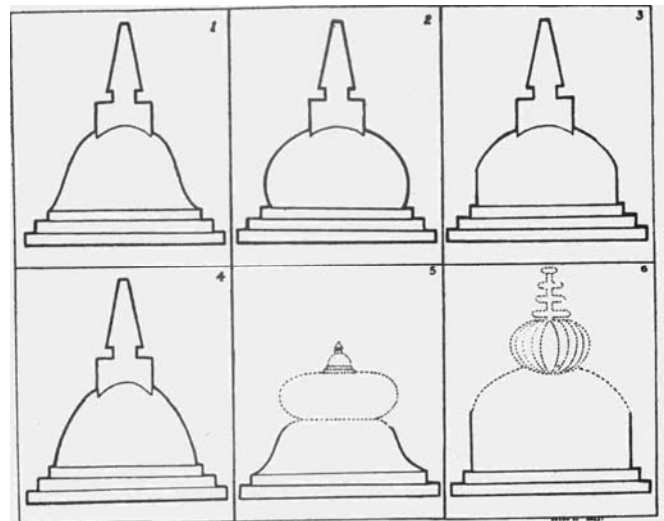
Figure 12. Stupa Shapes [Godakumbure 1976] (1-Bell, 2-Pot, 3-Bubble, 4-Paddy-heap, 5-Lotus, 6-Nelli fruit)

The dome is the biggest component of a stupa and it contains the relics, in a relic chamber, either at the level of the basal rings at the bottom, or at the square chamber at the top. Several shapes have been used for the dome (Fig. 12), and some examples are given in Table 2 and in Figs. 1 – 8.

The bell shape is the most common and next comes the bubble shape. The paddy-heap shape, having a gradient equal to the angle of repose, is the most stable from a structural point of view [Ranaweera 1998], and the ancient builders have used this shape for the colossal stupas they built [Silva 1982]. Domes of pot and lotus shapes are rare and there are no existing examples of the nelli fruit shape. The shape of the dome of some stupas has changed from their original form during repairs and enlargements which have taken place at later times. For example, the Thuparama (Fig. 1) was originally constructed with a paddy-heap shaped dome, which later took the shape of a bell.

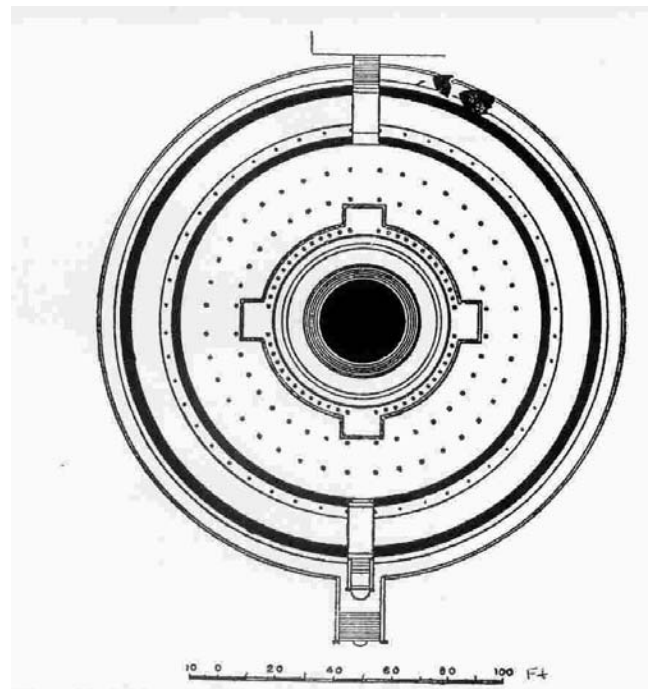
Figure 13. Ground Plan of Thuparama

Some of the small but important stupas, like the Thuparama (Fig. 1), were found on a raised platform with a circular plan (Fig. 13), and enclosed within a circular structure called the *vatadage*, with a roof (Fig. 14). Concentric circles of stone pillars carried the wooden roof of the structure, of which only some of the stone pillars remain at present (Fig. 1).

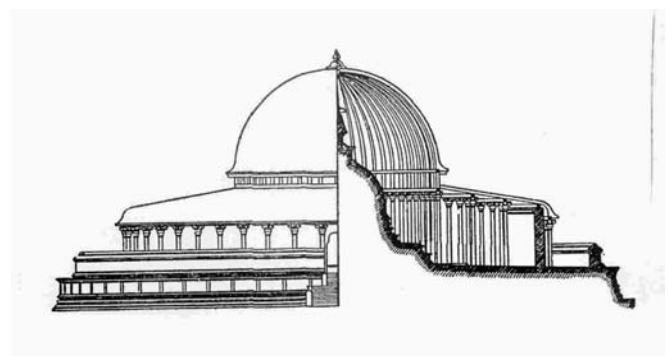
Figure 14. Conjectural Restoration of *Vatadage* of Thuparama [Paranavitana 1946]

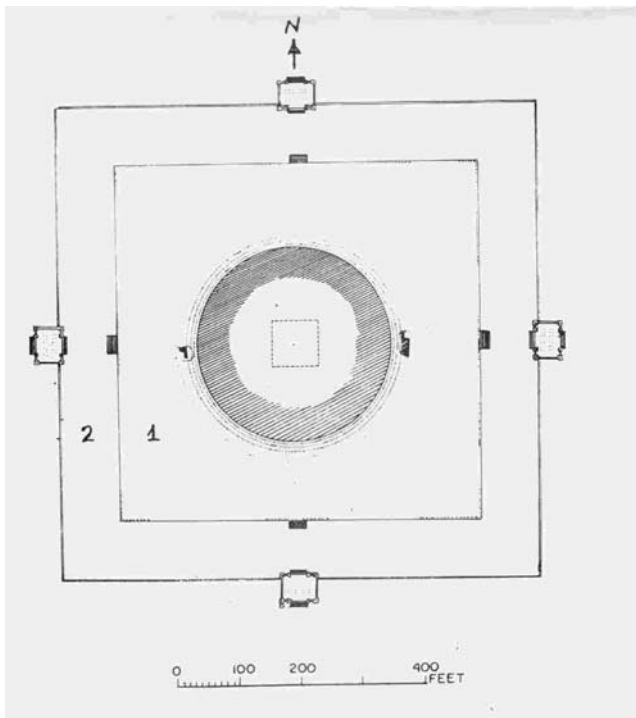
Figure 15. Ground Plan of Abaygiri Stupa (1-Platform, 2-Sand Terrace)

The large stupas sprang from a square stone-paved platform or an upper terrace raised from the ground and bounded by a retaining wall, and surrounded by a lower sand terrace at the ground level, also bounded by a wall, as shown in the plan of Abayagiri stupa (Fig. 15). Entrance gates and stone stairs are located at cardinal points, and the

The stupas are oriented along North-South East-West axes, and setting out has been done very accurately. In Abayagiri (present height 73.0 m, outer basal ring diameter 108.8 m) orientation of the boundary walls (Fig. 15) are within 1.5 degree accuracy and the top of the spire is almost in the same vertical line passing through the centre of the base (maximum shift is 23 mm) [Dampegama, 2001].

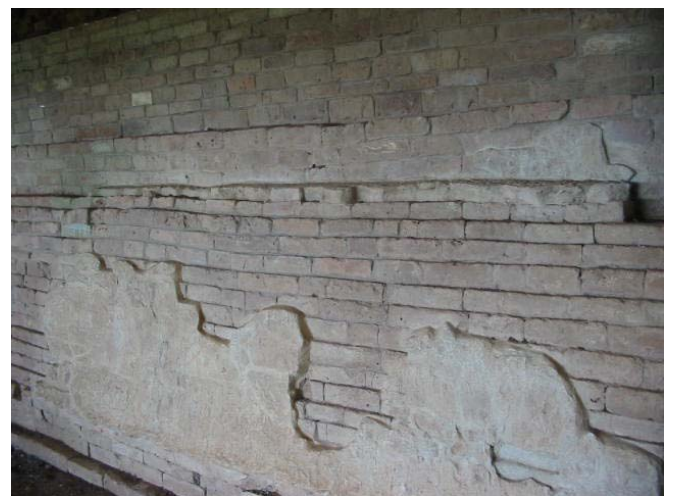
Figure 16. Ancient brickwork of Jetavan Stupa

The mortar used in ancient stupa construction is a very thin butter clay like a slurry. With this thin mortar the bricks essentially sit one on top of the other, the slurry filling the gaps (Fig. 16). This gives a strong brickwork, unlike the modern brickwork which uses a thick mortar which can weaken the brickwork. At the outer surface brickwork is water proofed using a thick plaster (Fig. 7, 16). Mahawamsa also describes stringent quality control of the materials used in ancient stupas.

The dome is a perfect solid of revolution, which is an ellipsoid for the Jetavana [Ranaweera 2000] and a paraboloid for the Abayagiri [Ranaweera 2001]. In some cases, for inner regions of the dome brickbats and earth have been used, while the outer regions were of strong large bricks. The surface was plastered with a thick lime plaster to prevent ingress of water (Fig. 7, 16).

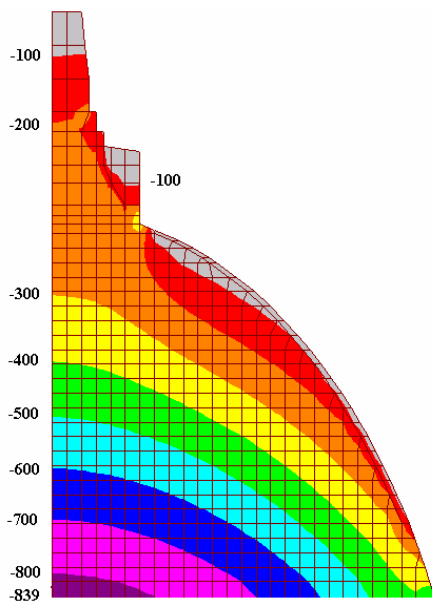
Figure 17. Contours of vertical stresses in Jetavana stupa (kPa)

strength point of view [Ranaweera 1998]. In the paddy-heap shaped dome of Jetavana, the largest stupa ever built, the maximum compressive stress occurs at the centre at foundation level and its value is 839 kPa (Fig. 17), around one tenth of the compressive strength of the ancient bricks used (Table 4). Hoop and radial stresses in Jetavana dome are also compressive having a maximum of 280 kPa at base centre. Pot shape domes have the largest tensile hoop stress region, as in the case of Tissamaharama stupa.

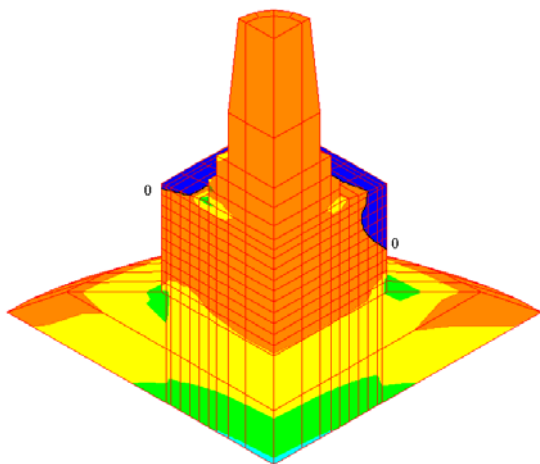
Figure 18. Stress contours in Jetavana stupa square chamber (tensile region shown darker)

The square chamber also has some tensile regions at the top, shown darkened in Fig. 18 for Jetavana.

To take up the hoop tension at the top (Fig. 18), a reinforced concrete ring beam was provided.

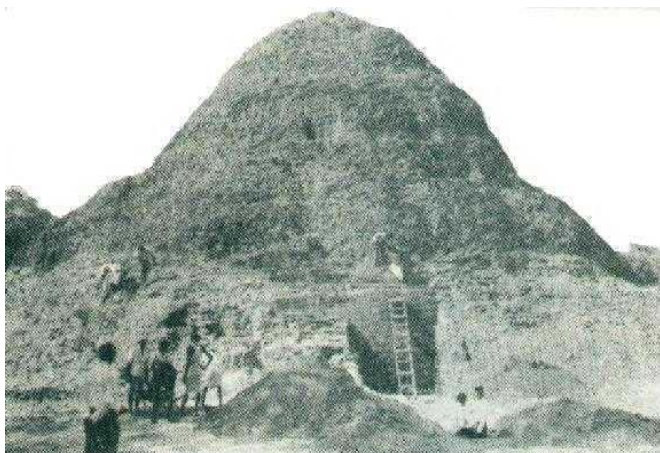
Figure 19. Miriseveti stupa after an unsuccessful restoration attempt

Restoration of Mirisaveti stupa is a good example of a complete restoration work by CCF. The stupa had only the cracked dome at the turn of the 19th century, and an ill planned restoration attempt in 1987 resulted in a collapse of the stupa which left only a conical mound of the weak inner core (Fig. 19). After much discussions and a thorough study including finite element analyses [Ranaweera 1993] the stupas was restored in 1995 to its original form with complete plastering (Fig. 3).

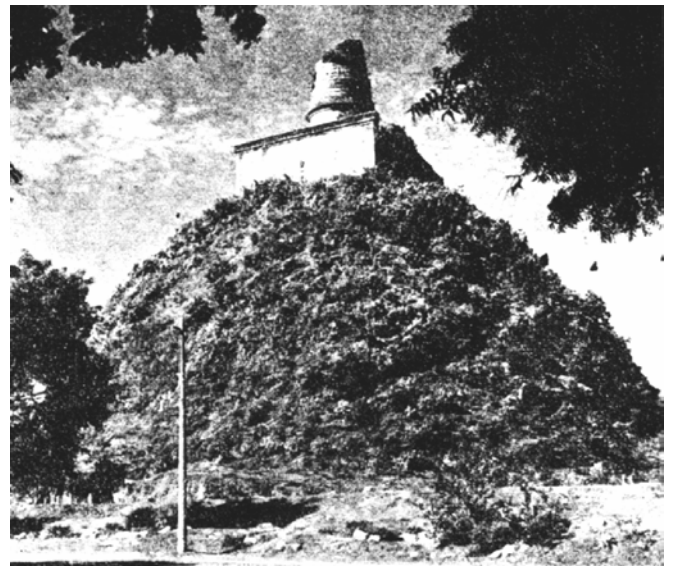
Figure 20. Jetavana stupa after decay

Conservation and restoration of stupas had been carried out by Kings of Sri Lanka from time to time. However by the turn of the 19th century most of the ancient stupas were in ruins, some turned into mounds of earth. During the last decade of the 19th century the British, ruling the country, did some restoration work, and later religious organizations undertook restoration works of many important stupas such as the Ruwanveli. However at the turn of the 20th century some major stupas such as the Jetavana (Fig. 20), Abayagiri (Fig. 5), and Miriseveti (Fig. 19) were still in ruins.
